APOLLO 13 MISSION  
HIGH-GAIN ANTENNA ACQUISITION PROBLEM

ANOMALY REPORT 2

December 1970

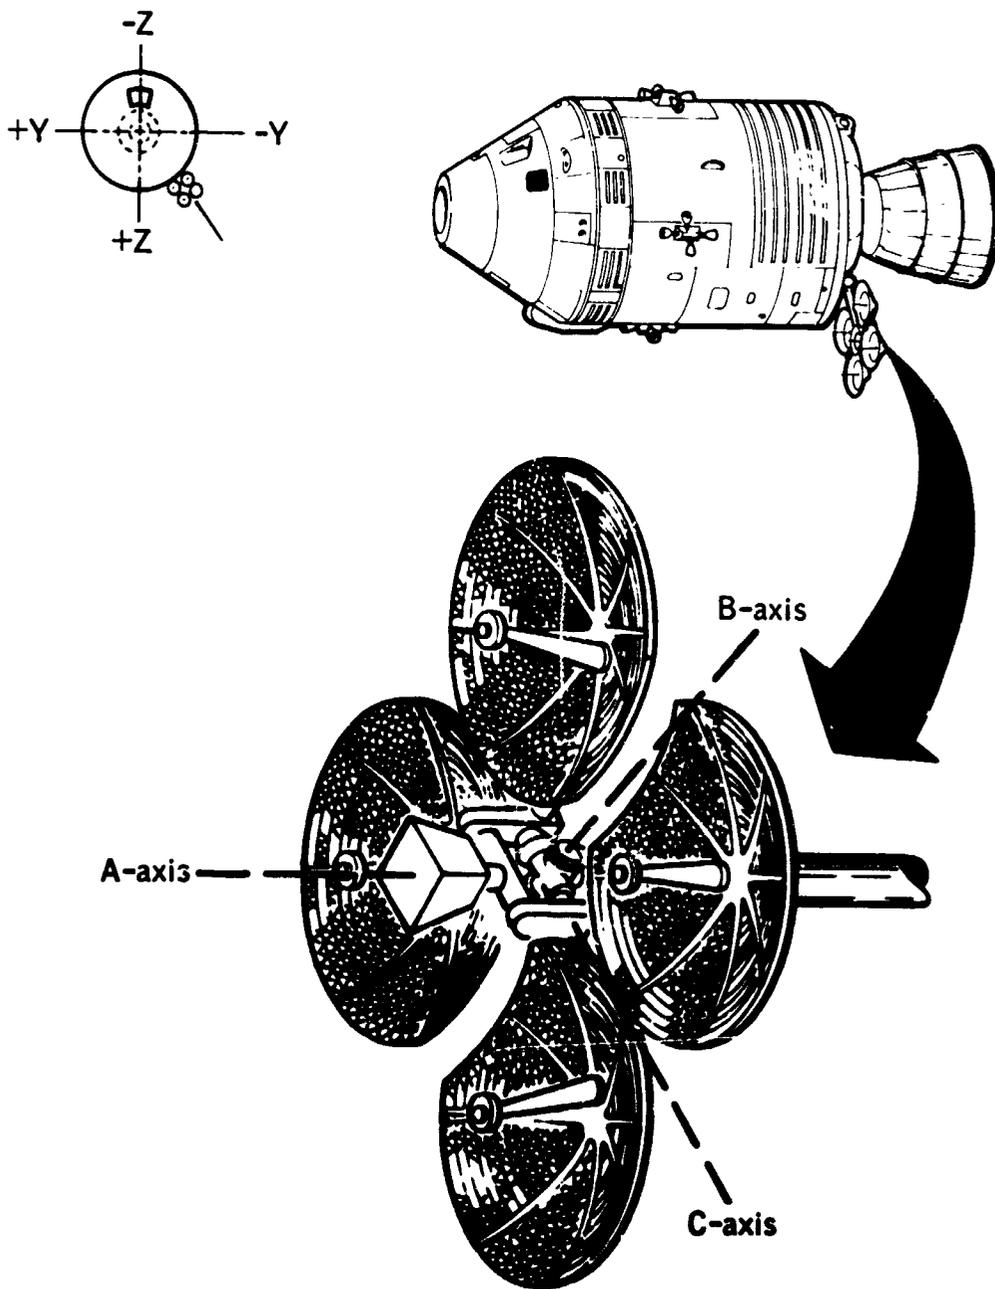
Figure 3.- Antenna gimbal axes.

The scan-limit and scan-limit-warning functions are generated by the C- and A-axis angles. The C- and A-axes are shown in figure 3. Figure 4 shows the scan-limit and scan-limit-warning function lines in the antenna coordinate (C- and A-axes) system. The C-axis and A-axis angle signals are generated in the high-gain antenna gimbals by two separate induction transducers. The C-axis signal comes from a linear induction potentiometer. The A-axis signal comes from a device similar to a synchro resolver. The A-axis signal is then half-wave, phase-sensitive demodulated, and the C-axis signal is half-wave rectified. The two signals and a dc bias are then summed by a differential amplifier shown on figure 5. The output of this summing amplifier is then compared to another dc bias voltage in a second differential amplifier. When the output of the first amplifier exceeds the dc bias supplied to the second amplifier, the second amplifier switches, indicating to the antenna logic that the scan-limit line has been reached. A similar circuit implements the scan-limit-warning line.

- a. The high-gain antenna is pointed using 3 gimbals (fig. 3). The B-axis is nulled out for A-axis and C-axis tracking and is used only for tracking where the boresight to the target passes close to the end of the antenna boom. The B-axis drive is then used to eliminate the requirement for high A-axis slewing rates. B-axis offset could not have caused the problem because if a maximum possible offset of about  $20^\circ$  existed, the A-axis and C-axis track loops would have detected and nulled out the offset without driving into the scan limit.

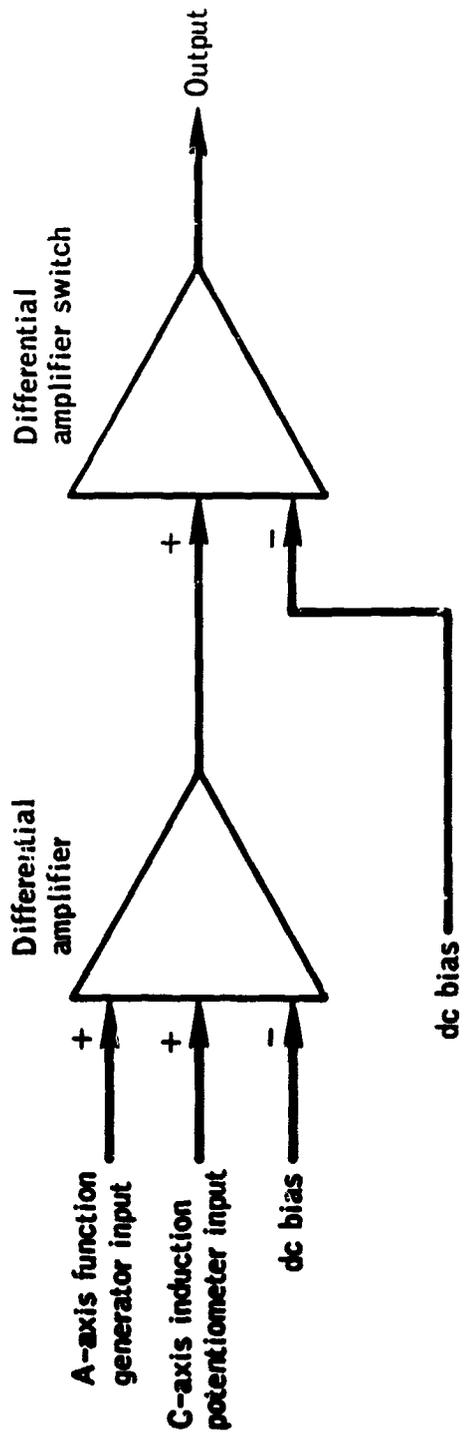
Figure 5.- Limit logic circuit.

c. Elements in the scan-limit and scan-limit-warning circuits were shorted and opened to determine the effect on the scan-limit functions. The results of this test shifted the scan-limit functions, but did not produce the necessary change in the scan-limit slope. Consequently, a failure in the electronic box is ruled out.
